MARTIN MARIETTA LABS BALTIMORE MD
CHARACTERIZATION OF ALUMINUM SURFACES PREPARED FOR ADHESIVE BON--ETC(U)
MAR 79 J D VENABLES, D K MCNAMARA, T S SUN F49620-78-C-0097
AFOSR-TR-79-0623 NL

4. TITLE (and Subtitle)	5. TYPE OF REPORT & PERIOD COVERED		
6 CHARACTERIZATION OF ALUMINUM SURFACES PREPARED FOR ADHESIVE BONDING	9 Interim repty		
7. AUTHOR(s)	6. PERFORMING ORG. REPORT NUMBER		
10 J. D. Venables, D. K. McNamara, T. S. Sun, B. Datchek, J. M. Chen

17. DISTRIBUTION STATEMENT (of the abstract entered in Block 20, if different from Report)	15a. DECLASSIFICATION/DOWNGRADING SCHEDULE		
18. SUPPLEMENTARY NOTES			
Proceedings of Structural Adhesive & Bonding Conference, March 1979

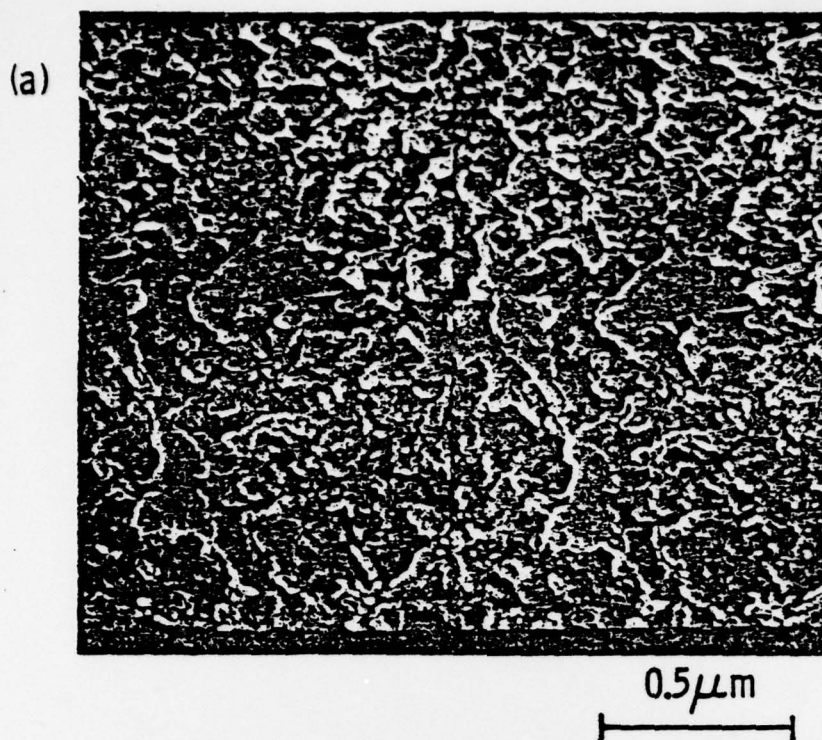
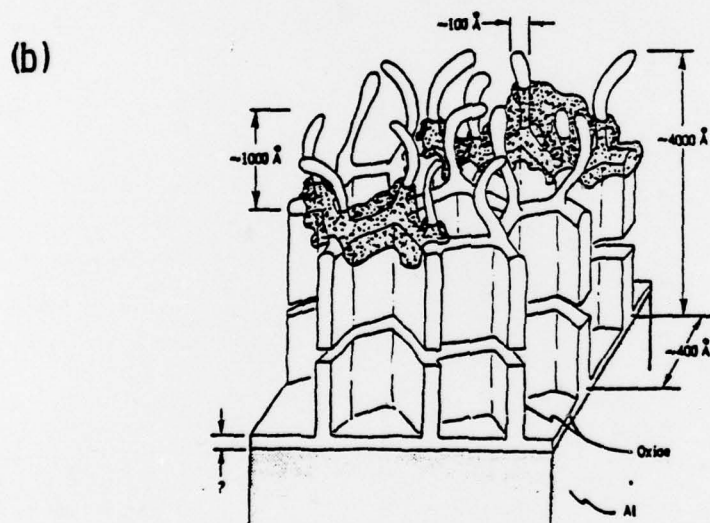
Figure 2. (a) Ultra-high resolution stereo SEM and (b) isometric drawing of a PAA surface after handling with bare fingers showing grease contamination.

To accomplish this, PAA treated surfaces were subjected to various "dirty" and "clean" handling techniques and then examined by STEM and Auger/ESCA. The results indicated that handling with bare fingers left a grease residue that completely covered the oxide allowing the underlying oxide whiskers to protrude in only a few regions, Fig. 2. Similar handling, but with a sheet of "off-the-shelf" aluminum foil placed between the fingers and the PAA surface also resulted in extensive grease contamination as observed by STEM and Auger. However, when the Al foil was first cleaned by etching in 0.1 N NaOH at 25°C, no evidence for any contamination or mechanical damage could be observed. Evidently, Al foil contains a film of grease, probably a residue from lubricants used in the rolling operation, which is sufficient to contaminate the PAA surface. When this is removed by etching, the PAA surface can be handled through the foil intermediary with no resulting effect on the surface at all.

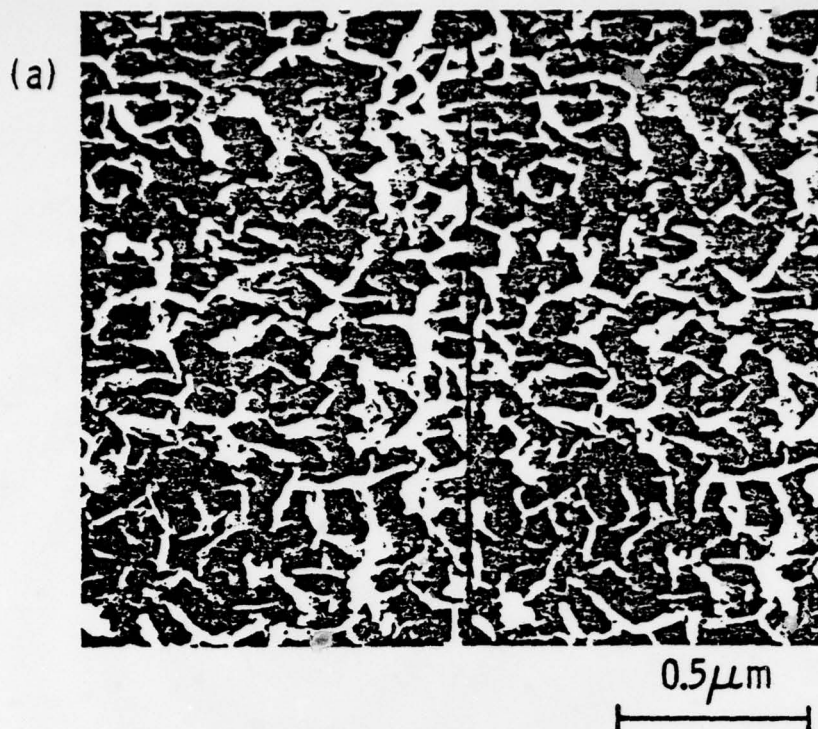
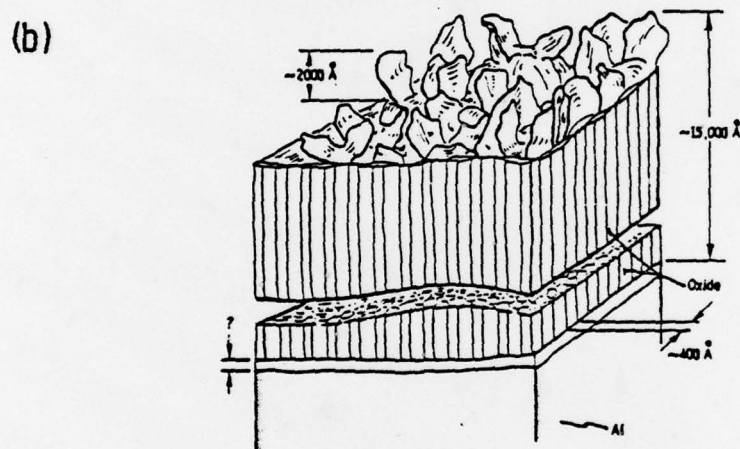
Figure 4. (a) Ultra-high resolution stereo SEM and (b) isometric drawing of a CAA surface after "sealing" showing hydroxide formation on upper surface.

The "sealed" CAA surface exhibits a morphology, Fig. 4, which, for obvious reasons, we have dubbed the "cornflake" structure. The surface

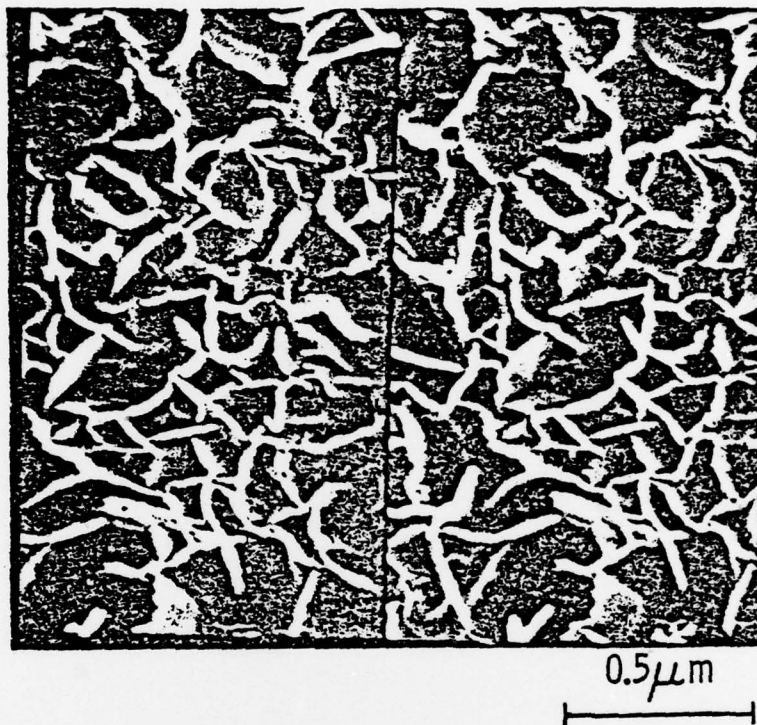
Figure 5. Ultra-high resolution stereo SEM of hydroxide morphology picked up on adhesive side of crack interface during a humidity wedge test.

of adherends subjected to a humidity chamber wedge test in which the crack propagated along the adhesive/adherend interface, exhibits an identical structure as shown in Fig. 5. This morphology has been observed previously by Vedder and Vermilyea⁽⁷⁾ who used TEM and infrared spectroscopy to identify it as crystalline pseudo-boehmite, a material containing somewhat more water than perfectly crystallized boehmite. Our analysis, which indicates that the crystal structure is that of crystalline boehmite is consistent with that of Vedder and Vermilyea; we would not argue the point that it may contain somewhat more water than true boehmite. In any event, the distinct "cornflake" morphology, and the crystalline nature of the substance, appear to be characteristics of hydrated films that set them apart from films on freshly prepared adherends.
